Manhole Inspection Summary

Manhole # S29S1_030MH

Record Plat: **29S1** Node: **030** Status: **New Manhole (Not in GIS)** Insp Date: **4/9/09 12:00 AM**

Location Address: **Denham circle**

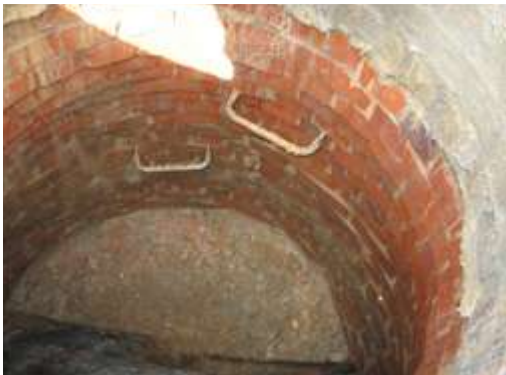
steps

Steps Count: **2** Missing: **0** ☐ Corroded

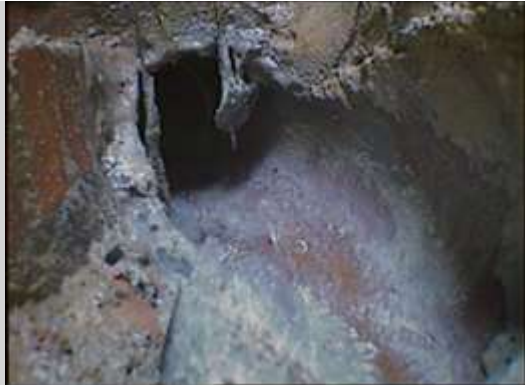
12 O'Clock Outflow

8 in. Circular Gravity Sewer
Pipe Out @ 12 O'Clock

Pipe Height: **10.8** (in.) Rod and Bar (Angled)
Pipe Material: **Clay** ☐ Pipe Lined
Invert Depth: **7.98** (ft.) Flow Characteristics: **Fast**
Deposits: ☒ None ☐ Mud ☐ Sludge ☐ Debris ☐ Grease
Silt Depth: (in.) Deposits Extent:
Infiltration: **None** Pipe Seal Cond: **Sound**

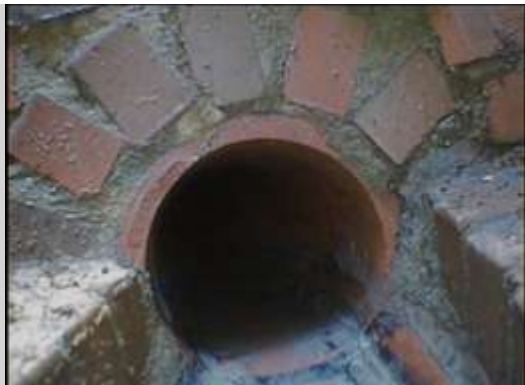
6 O'Clock Inflow

8 in. Circular Gravity Sewer
Pipe In @ 6 O'Clock

Pipe Height: **10.8** (in.) Rod and Bar (Angled)
Pipe Material: **Clay** ☐ Pipe Lined
Invert Depth: **7.50** (ft.) Flow Characteristics: **Fast**
Deposits: ☒ None ☐ Mud ☐ Sludge ☐ Debris ☐ Grease
Silt Depth: (in.) Deposits Extent:
Infiltration: **None** Pipe Seal Cond: **Sound**
